Manhole Inspection Summary

Manhole # S63G__022MH

Insp Date: **5/14/08 11:01 AM**

Location Address: **alley behind 401 Anglesea St.**

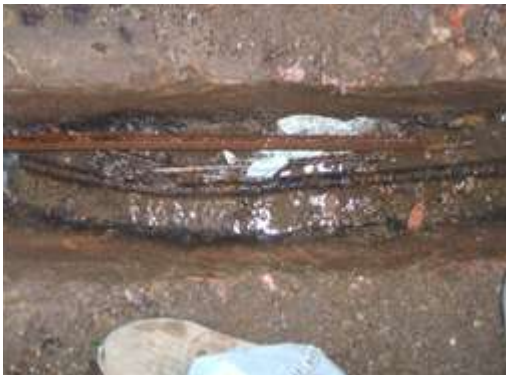
Defect 2

Comments **MANHOLE COULD USE CLEANING. THERE IS SOME HEAVY DEBRIS THAT COULD CATCH LIGHTER DEBRIS CAUSING A SURCHARGE CONDITION.**

Condition: ☐ Sound ☐ Cracked ☐ Root Intrusion ☐ Deteriorated ☐ Leaks ☒ **Debris**

debris in channel

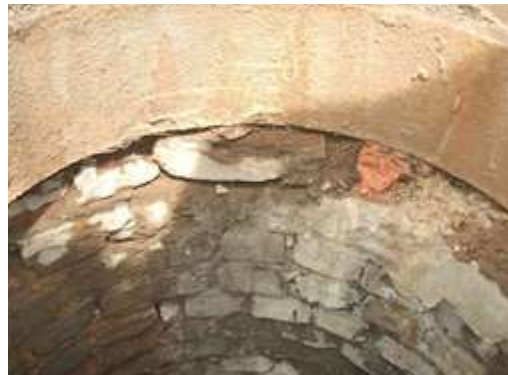
Defect 7

Condition: ☐ Sound ☐ Cracked ☐ Root Intrusion ☒ **Loose Brick** ☒ **Deteriorated**

loose bricks under frame

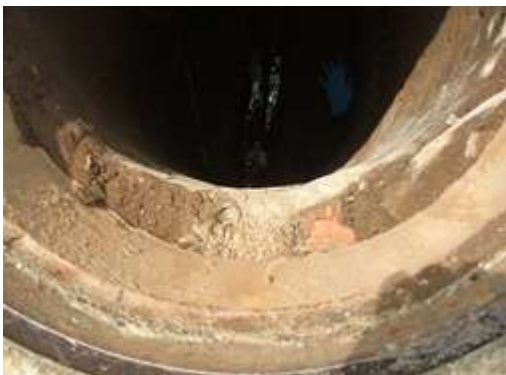
Defect 5

Frame Offset: **3** (in.) Condition: ☒ Sound ☐ Cracked ☐ Leaks

offset frame

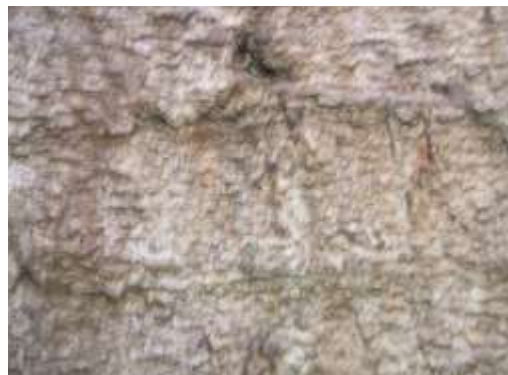
Defect 3

Infiltration: ☐ None ☒ **Joint** ☐ Cracks ☒ **Mortar** ☐ Roots ☐ Wall

infiltration on barrel wall

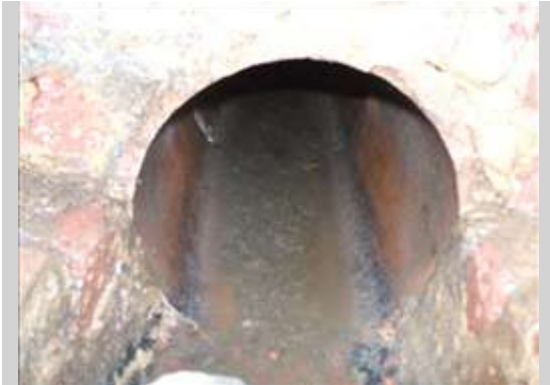
12 O'Clock Outflow

Deposits: ☐ None ☐ Mud ☒ **Sludge** ☐ **Debris** ☐ Grease

Silt Depth: **0.25** (in.) Deposits Extent: **Light**

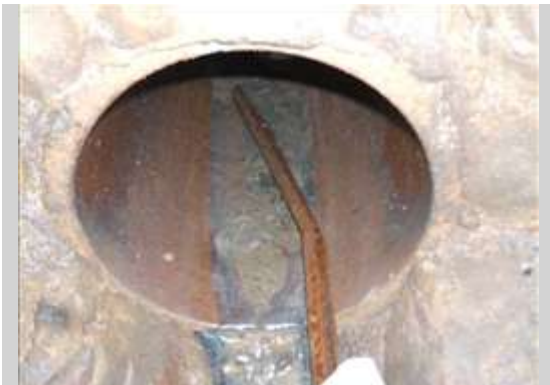
6 O'Clock Inflow

Deposits: ☐ None ☐ Mud ☐ Sludge ☒ **Debris** ☐ Grease

Silt Depth: **1** (in.) Deposits Extent: **Medium**
